A checklist for assessing the hazard potential of glacier lakes

Example: Laguna 513, Peru

To demonstrate the concept, the checklist was applied to Laguna 513, a proglacial lake in the Cordillera Blanca, Peru, which burst out in April 2010 after a rock-ice avalanche hit the lake.

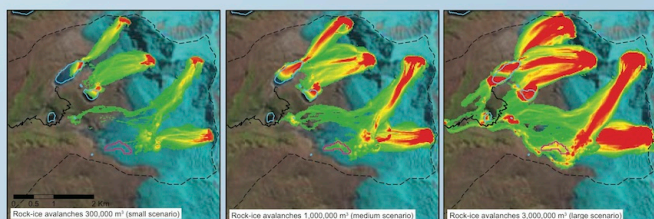
RAMMSS model results of potential ice avalanches at Mt. Hualcán.
(D. Schneider)

• ...rock/ice avalanches impacting the lake? (indicated by steep hanging glaciers, unstable rock formations)	High potential for rock/ice avalanches from various potential starting zones at Mount Hualcán (cf. historic events).	Rock-ice avalanches are possible anytime, also of large volumes (> 1 Mio m³).	An early warning system is currently being installed. Geophones have been deployed to register larger mass movements in the surrounding of Laguna 513. Cameras observing the dam and the flanks of Mt. Hualcán are constantly taking pictures of the situation (accessible online at http://inkanautas.com).

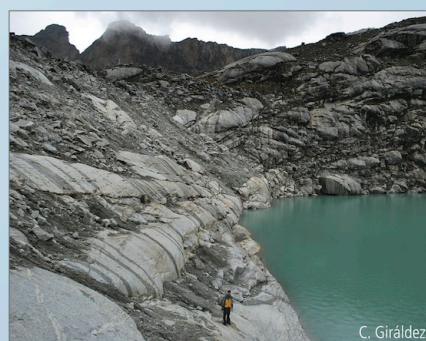
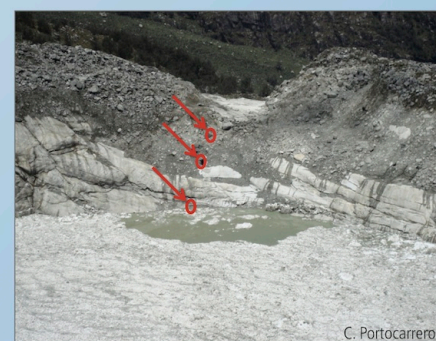
Photos: Rock dam of Laguna 513, ~25 m high, morainic material on top. Drainage tunnels have been drilled through the bedrock in the 1990s, indicated by the red arrows in the right photo. The lake level is therefore constant. The right photo was taken two days after the outburst in 2010 (note the avalanche ice still floating on the lake).

Item	Data / evidences	Assessment	Remarks / recommendations
Characteristics	Rock dam with morainic material on top (see photo). A breach exists in the moraine.	Dam considered as stable. However, overtopping is possible in case of an impact wave (cf. past events and traces)	Inlets of the drainage tunnels need to be checked regularly.
Conditions	High freeboard (> 25 m), stable lake level (controlled by tunnels in the bedrock). Blocking of the lowest outlet tunnel possible (-> increase of lake level by 20 m)		Construction of another, lower tunnel planned by the municipality. This would further increase the freeboard and lower the hazard potential
	Surface outlet existing? Potential for blocking of outlet by ice blocks or floating snow?
